NRL Report 5920

Fracture Analysis Diagram Procedures for the Fracture-Safe Engineering Design of Steel Structures

W. S. PELLINI AND P. P. PUZAK
Metallurgy Division

March 15, 1963

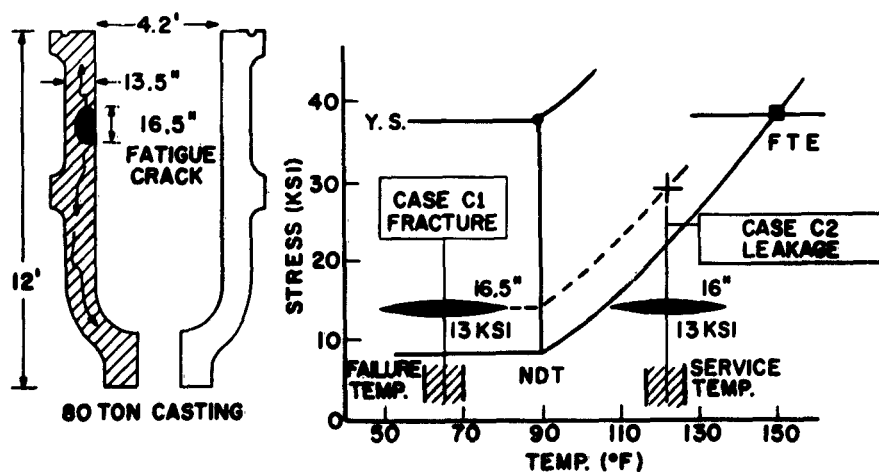
Fig. 49 – (Case C1) Fracture analysis relating to the service failure below the NDT of an ASTM A27 cast-steel extrusion press cylinder. (Case C2) Fracture analysis relating to leakage failure above the CAT of a similar cylinder for a smaller press operating at a higher service temperature.

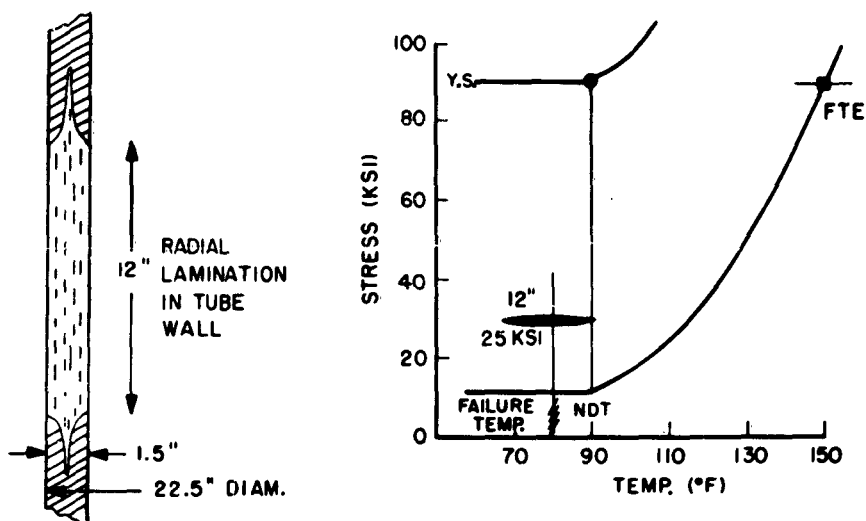
Fig. 51 — (Case C3) Fracture analysis relating to the air-leak test failure of an ASTM A372-IV high pressure air flask

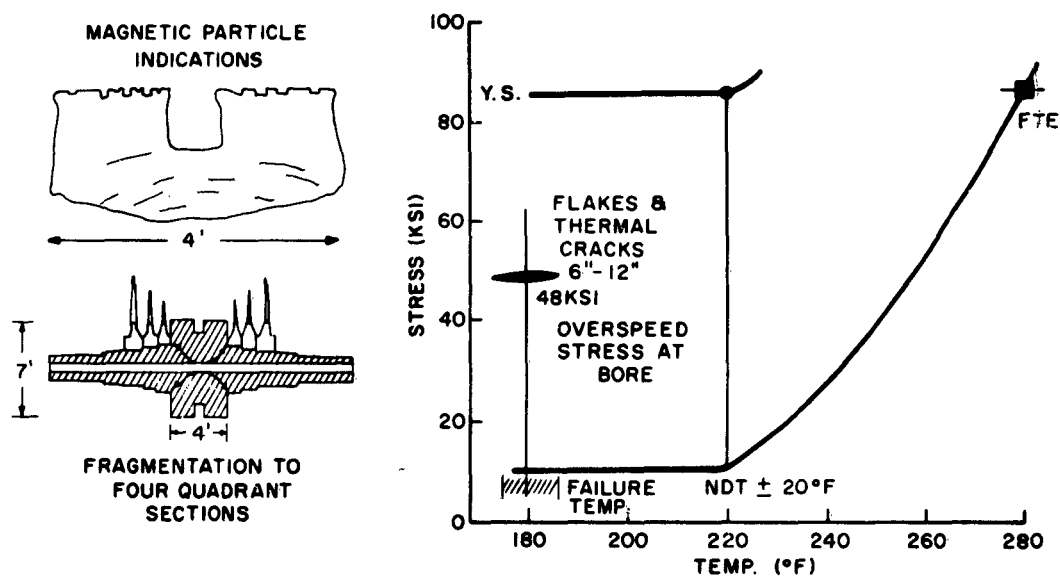
Fig. 53 - (Case C4) Fracture analysis relating to the overspeed failure of the ASTM A293 turbine spindle forging

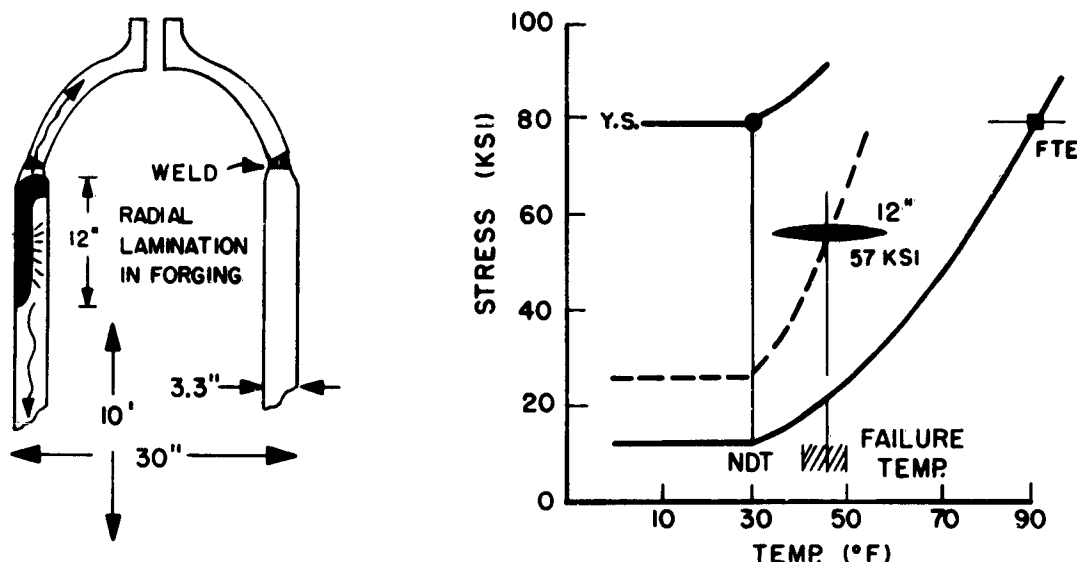
Fig. 55 — (Case D1) Fracture analysis relating to the hydrotest failure of the ASTM A302-B gas flask

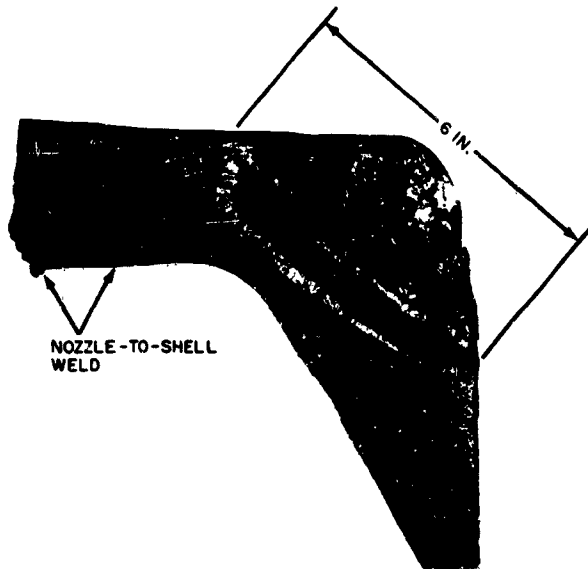
Fig. 57 - (Case E1) PVRC #1 vessel fracture surface illustrating the 6-in. fatigue crack at the nozzle source point (located by the arrow in Fig. 54).

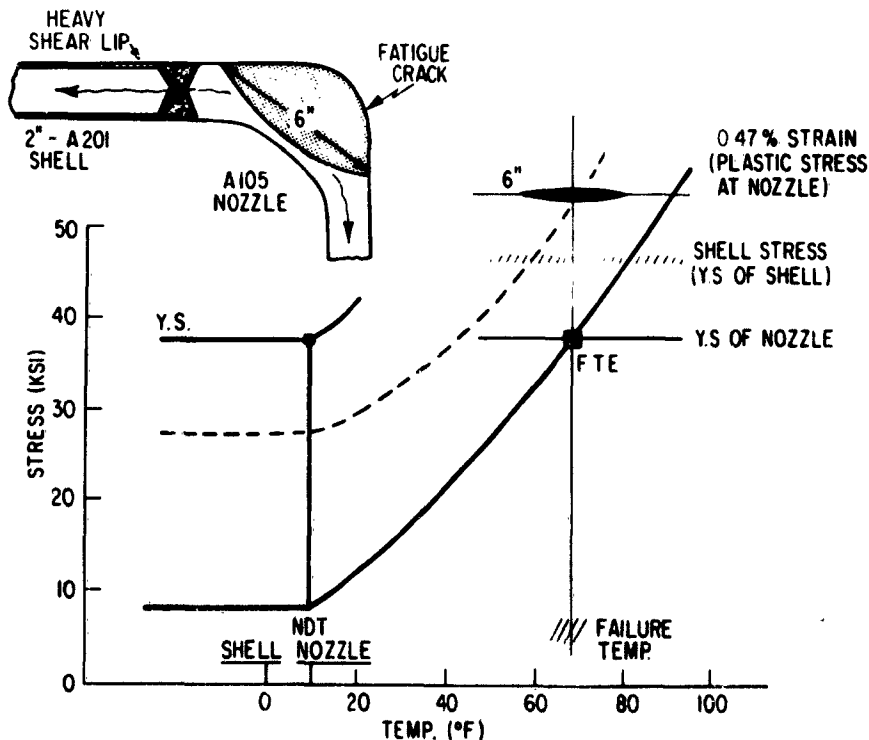
Fig. 58 - (Case E1) Fracture analysis relating to the failure of the PVRC #1 vessel which originated from a 6-in. fatigue crack in a forged ASTM A105 nozzle

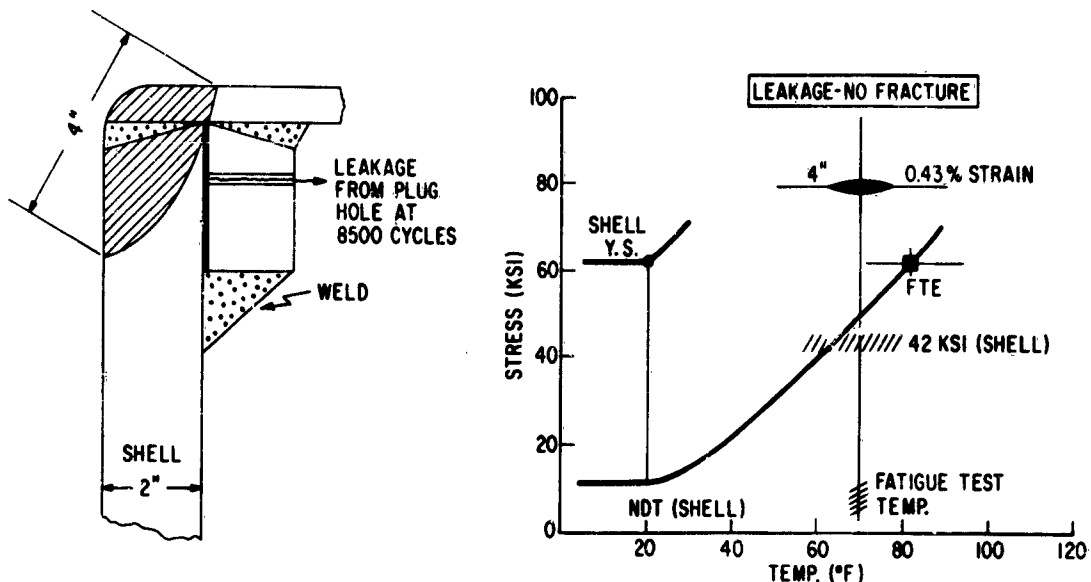
Fig. 61 - (Case E3) Fracture analysis of the flaw size and stress conditions that were inadequate for fracture initiation in the A182-F1 forged nozzle of the PVRC #3 pressure vessel

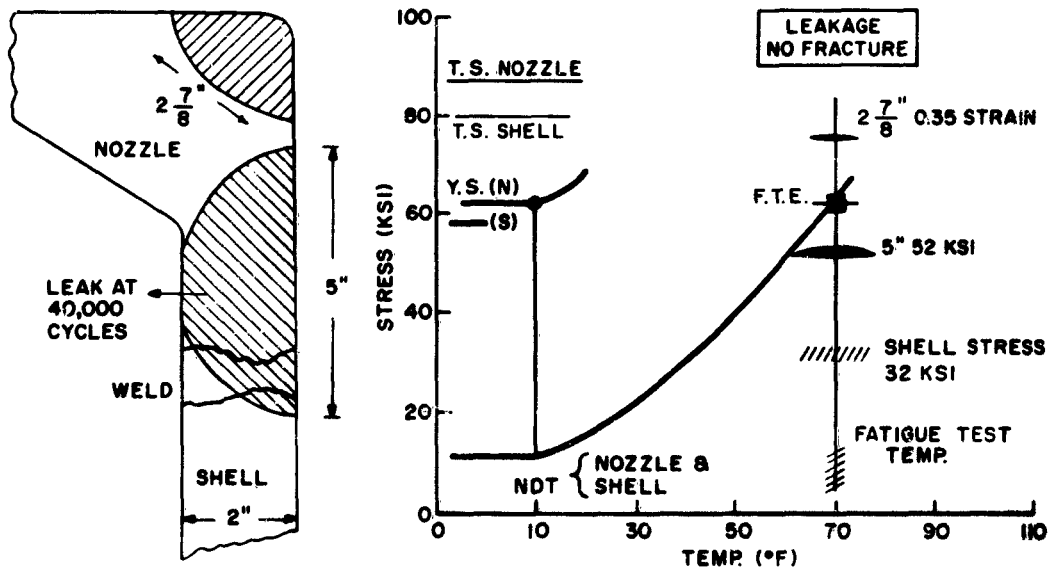
Fig. 63 — (Case E4) Fracture analysis of the flaw size and stress conditions that were inadequate for fracture initiation in the ASTM A182-F1 nozzle and the ASTM A302-B shell of the PVRC #4 vessel

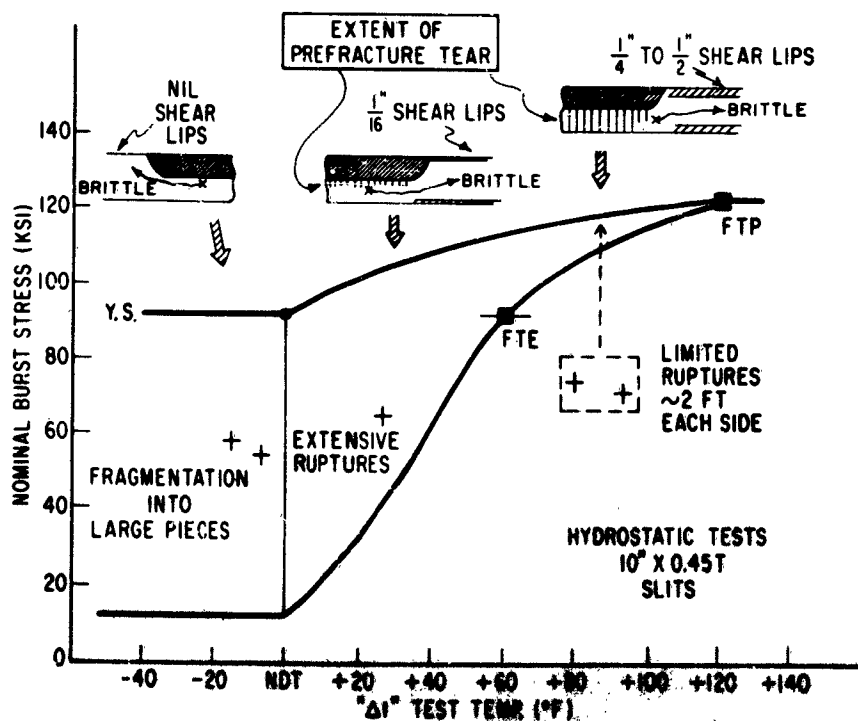
Fig. 64 - (Cases F1 to F5) Summary of hydrostatic burst test data

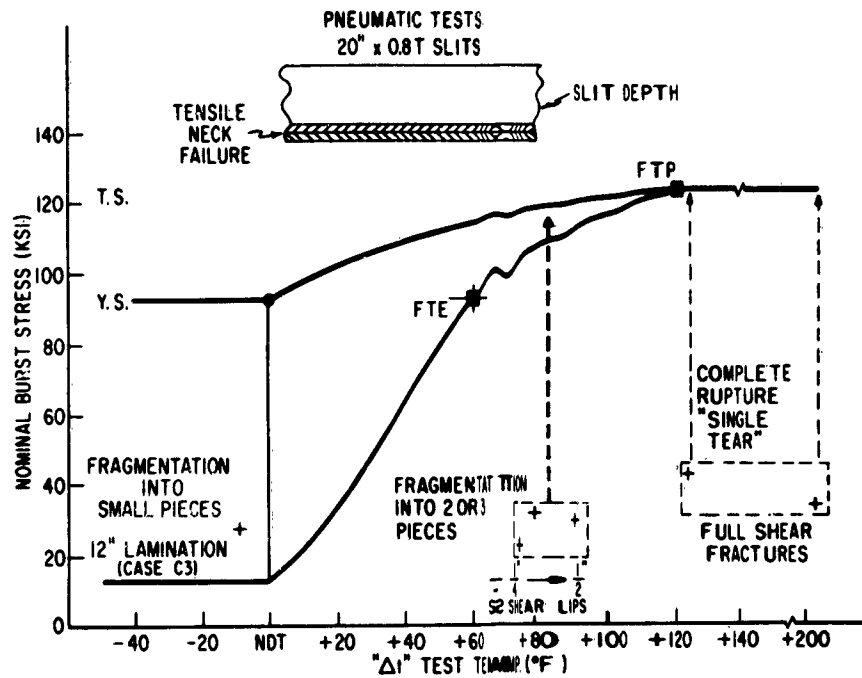
Fig. 66 — (Cases F6 to F11) Summary of pneumatic burst test data

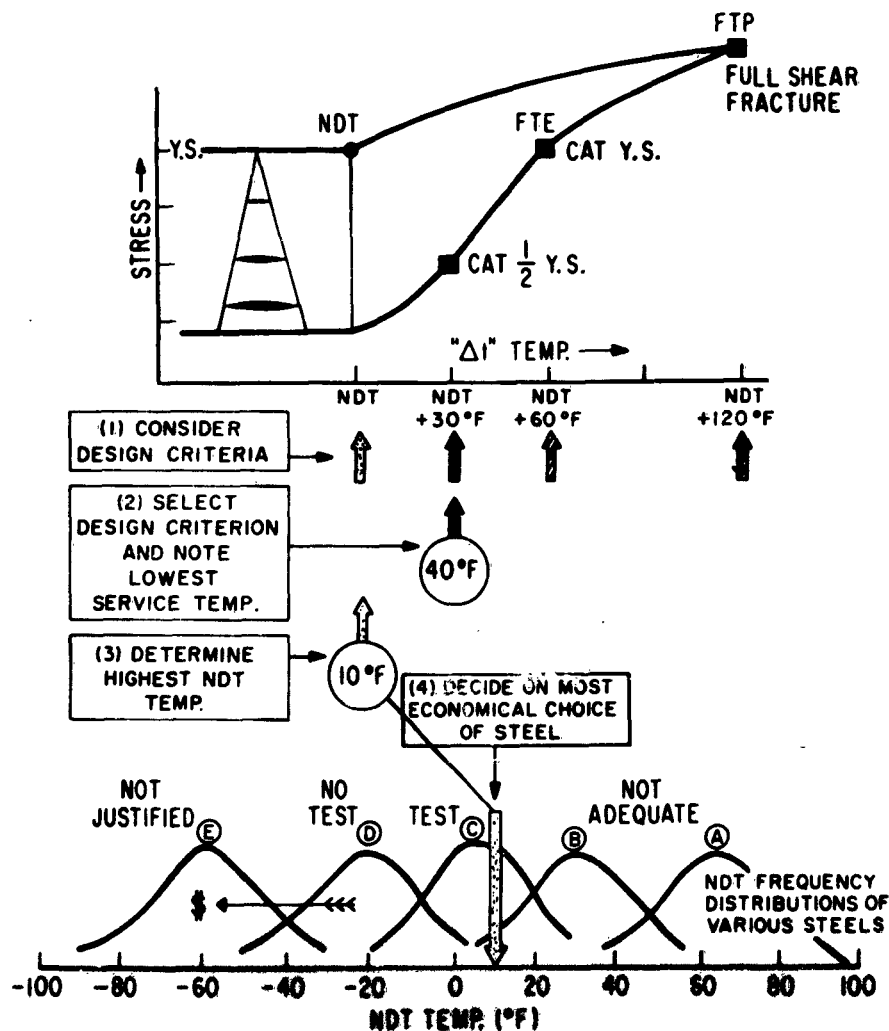
Fig. 68 - An example illustrating the four simple steps for the engineering selection of fracture-safe steels based on the fracture analysis diagram concepts and a catalog of NDT data.
